Manhole Inspection Summary

Manhole # S49CC_042MH

Insp Date: **2/19/08 8:40 AM**

Location Address: **Lakewood**

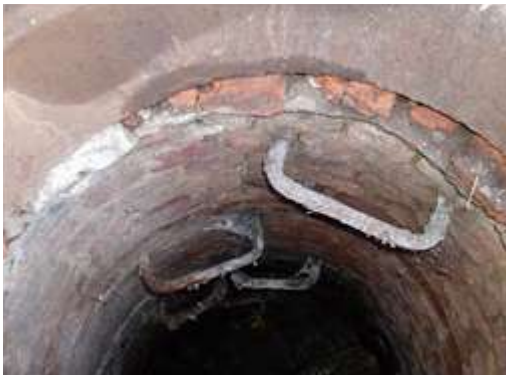
Defect 2

☒ **Leaks**

Frame Leaks

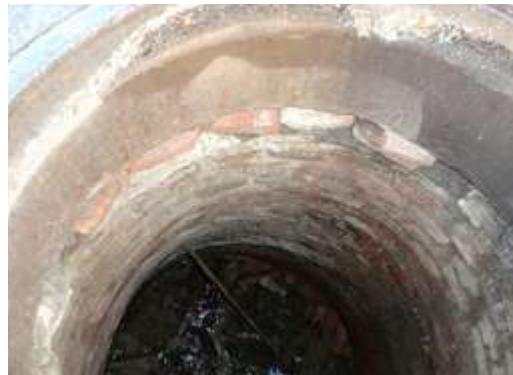
Defect 1

Condition: ☐ Sound ☐ Cracked ☐ Root Intrusion ☒ **Loose Brick** ☐ Deteriorated

Infiltration: ☐ None ☒ **Joint** ☐ Cracks ☒ **Mortar** ☐ Roots ☐ Wall

Loose Bricks

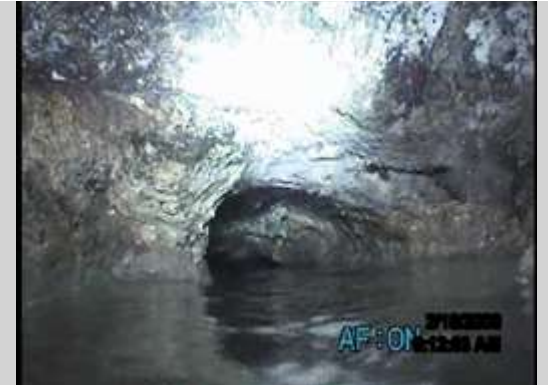
12 O'Clock Outflow

8 in. Circular Gravity Sewer
Pipe Out @ 12 O'Clock

Pipe Height: **4.8** (in.) Rod and Bar
Pipe Material: **Clay** ☐ Pipe Lined
Invert Depth: **8.60** (ft.) Flow Characteristics: **Fast**
Deposits: ☐ None ☒ Mud ☒ Sludge ☒ Debris ☒ Grease
Silt Depth: **4** (in.) Deposits Extent: **Medium**
Infiltration: **None** Pipe Seal Cond: **Sound**

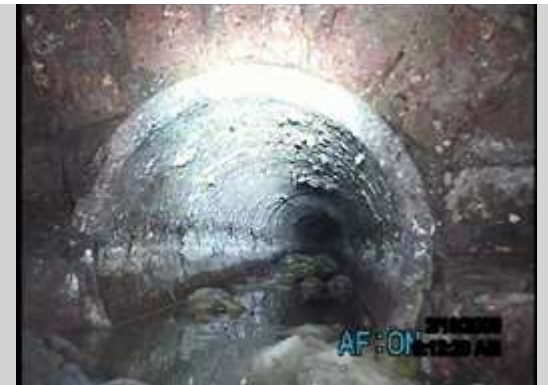
3 O'Clock Inflow

8 in. Circular Gravity Sewer
Pipe In @ 3 O'Clock

Pipe Height: **8.4** (in.) Rod and Bar (Angled)
Pipe Material: **Clay** ☐ Pipe Lined
Invert Depth: **8.90** (ft.) Flow Characteristics: **Slow**
Deposits: ☐ None ☒ Mud ☒ Sludge ☒ Debris ☒ Grease
Silt Depth: **6** (in.) Deposits Extent: **Heavy**
Infiltration: **None** Pipe Seal Cond: **Sound**

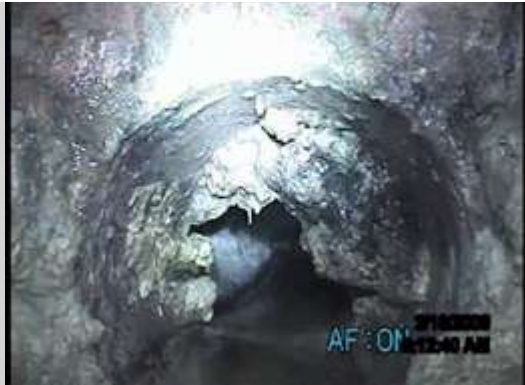
9 O'Clock Inflow

Deposits: ☐ None ☐ Mud ☐ Sludge ☐ Debris ☒ **Grease**

Silt Depth: **2** (in.) Deposits Extent: **Light**
